# Dashboard renovation technology for vintage vehicles

Dashboard, Renovation technology, Vintage vehicle

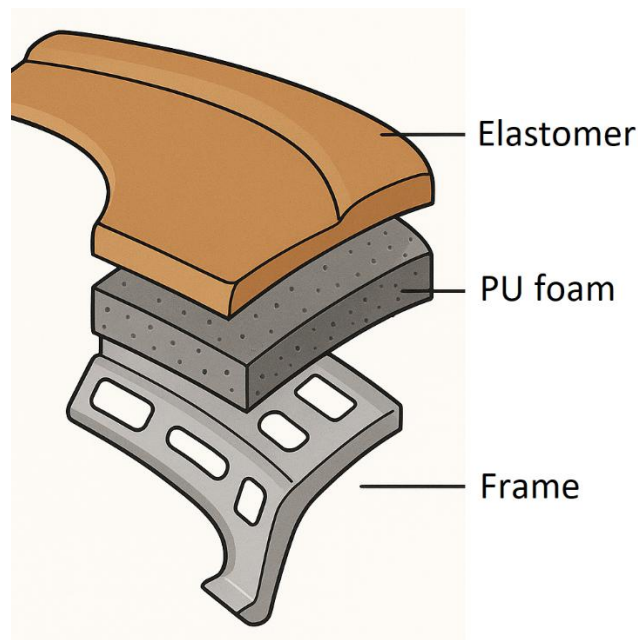
The structural backbone of contemporary instrument panels is usually a rigid carrier made from polypropylene (PP), ABS (acrylonitrile-butadiene-styrene), or fiber-reinforced composites. These materials provide high dimensional stability, favorable molding characteristics, and compatibility with integrated mounting points for electronics, HVAC systems, airbags, and steering-column components. Fiber reinforcement—commonly glass fibers—is often incorporated to increase stiffness while maintaining comparatively low weight. The structural layout of a typical dashboard is illustrated in Figure 1.

*Figure 1. Dashboard structure*

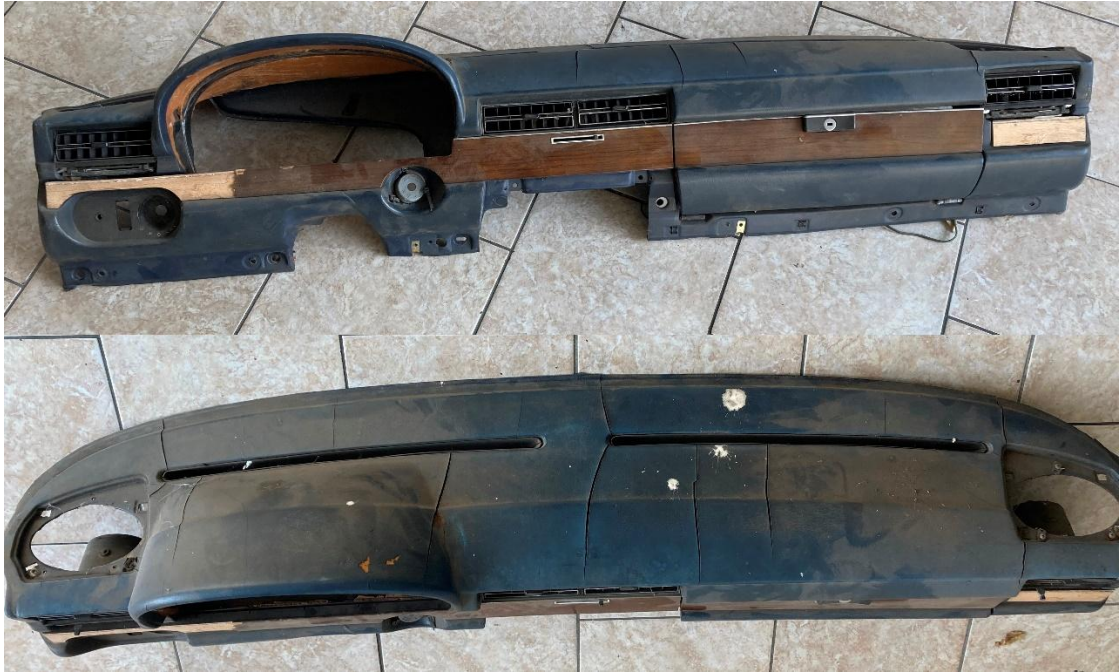
Figure 2. Dashboard removed for renovation

yields better results, because it allows access to the back side of the structure and provides a stable working environment. Removal typically involves detaching trim panels, disconnecting wiring harnesses for gauges and switches, loosening mounting bolts, and carefully sliding the dashboard out of the cabin. After removal from the vehicle, the dashboard was cleaned using a neutral detergent solution at 35–40 °C, followed by air drying for 12 h. Solvent-based cleaners must be used sparingly to avoid further damaging the aged materials.

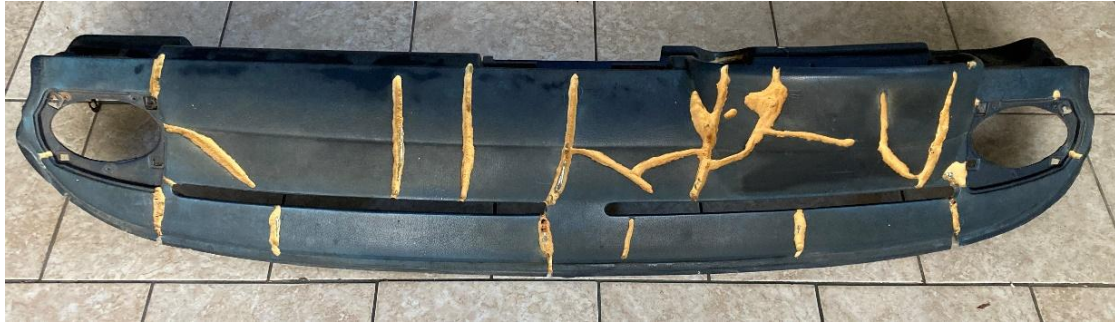
Figure 3. U-shaped cracks milled into the dashboard

Once the surface is clean, the cracks must be prepared for repair. Somewhat counterintuitively, restorers often widen the cracks slightly to remove brittle material and to create a V- or U-shaped channel that allows the repair compound to bond more effectively. A rotary tool with a controlled-speed 8,000–12,000 rpm, burr, or a sharp utility knife, can be used for this shaping process. Care must be taken to avoid cutting into reinforcement structures beneath the vinyl or plastic surface. After shaping, the cracks should be cleaned again, this time using a plastic-safe degreasing agent. At this stage, some restorers reinforce large cracks with backing material from behind the dashboard. Fiberglass mesh or flexible plastic strips can be glued behind the crack using epoxy resin, helping stabilize the repaired area and preventing future splitting.

The geometric parameters of the channel indicate that the depth ranges from 4 to 10 mm, while the width ranges from 2 to 10 mm. Cracks longer than 50 mm were reinforced from the rear side using fiberglass mesh bonded with epoxy adhesive. The technical parameters are listed in the table below.

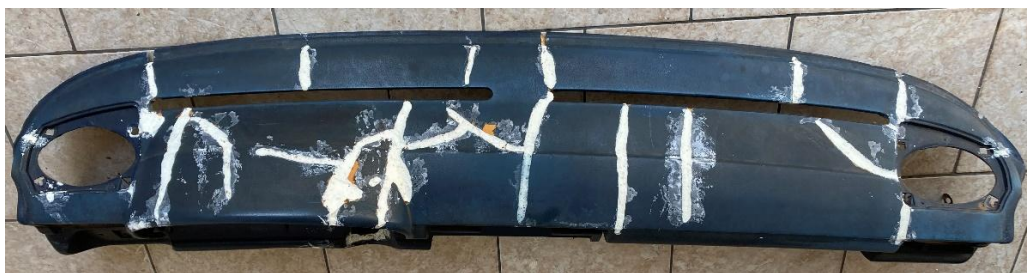
Figure 4. Polyurethane foam filled channels

In dashboards where the underlying foam has collapsed or separated from the surface layer, reconstruction is necessary. Expanding polyurethane foam or two-part flexible filler compounds can be used to rebuild the damaged areas. The foam is typically applied from the underside or injected through small access holes. After curing, the foam is trimmed and sanded to match the original contour. The next step is restoring the outer surface. Specialized dashboard repair fillers—usually flexible epoxies, urethane-based compounds, or vinyl repair materials—are applied into the widened cracks. The filler must be spread smoothly using a plastic applicator and then sanded lightly with fine-grit sandpaper. Multiple application and sanding cycles may be necessary to achieve a seamless transition between repaired and original areas.

Collapsed foam regions were reconstructed using two-component expanding polyurethane foam. The technical parameters are listed in the table below.

After curing, excess foam was trimmed and sanded (P240–P320). Surface contour tolerance was maintained within  $\pm 0.5$  mm compared to original geometry.

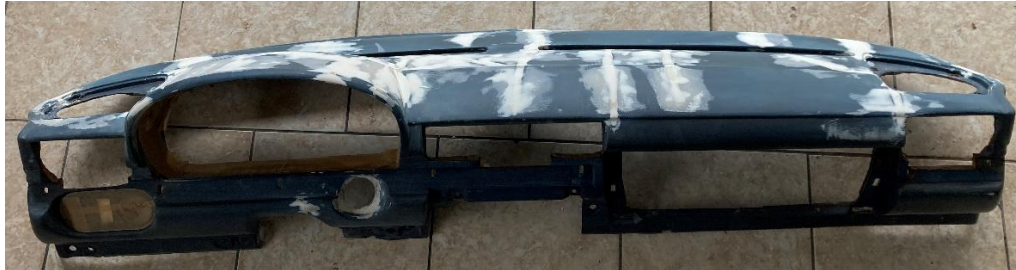
*Figure 5. Primed surface prepared for texturing*

To create the surface pattern, it is necessary to prime the polished prepared surface, which ensures the closure of the pores and the adhesion of the next layer. Flexible urethane filler was applied into prepared channels.

The application parameters were as follows: a maximum thickness of 2 mm per layer, a flash-off time of 30–40 minutes between layers, a final curing time of 4 hours before sanding, and final sanding prior to priming performed with P400–P600 grit abrasives. A plastic adhesion promoter was applied in a thin, uniform layer with a wet film thickness of 8–12  $\mu\text{m}$  and a flash-off time of 10 minutes. The flexible primer was applied using an HVLP spray gun with a 1.7 mm nozzle at a pressure of 1.8–2.0 bar, achieving a dry film thickness of 25–35  $\mu\text{m}$ , with a 15-minute flash-off time between coats; it was sandable after 2 hours, reached full cure after 12 hours, and was lightly sanded with P600 prior to texturing.

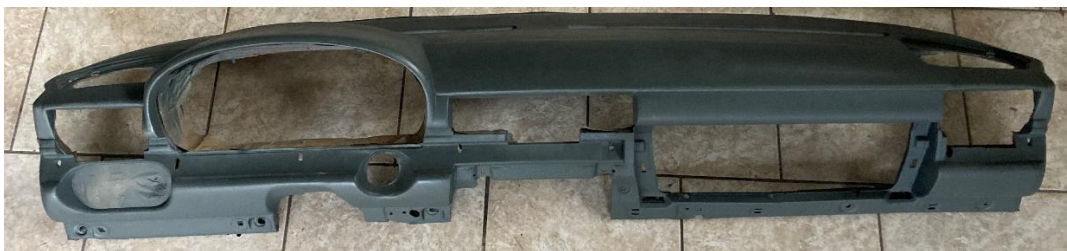
*Figure 6. Textured polyester-sprayed surface*

One of the most critical and challenging steps is reproducing the texture of the original surface. Dashboards from different eras and manufacturers featured various grain patterns, ranging from fine-pebble vinyl textures to deeper sculpted grains. To replicate these textures, technicians often use grain pads or molds. A grain mold can be created by pressing a silicone molding material onto an undamaged section of the dashboard or a similar surface. Once cured, this customized mold is used to imprint texture onto the repair compound. Heat guns or specialized thermal pads help soften the surface for correct impression transfer. For more uniform textures, pre-manufactured grain papers or spray-on texture coatings can also be used, though precision molds typically yield more authentic results.

In most cases, textured polyester filler can be applied to the prepared primed surface, although with this method the surface pattern differs slightly from the original, however this does not affect the veteran certification process and is a significantly cheaper solution. The technical parameters of the polyester texture applied by spray paint are shown in the table below.

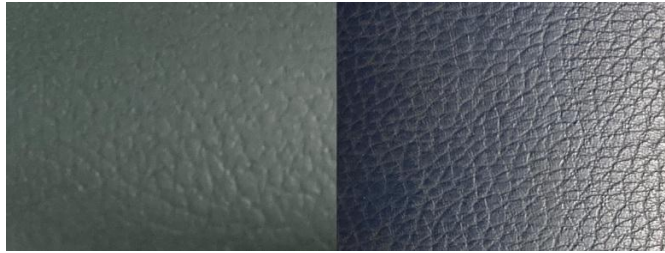
*Figure 7. Original surface texture (right) and surface sprayed with textured polyester filler (left)*

The curing time was 30 minutes to become dust-free, 4 hours before recoating, and 24 hours to reach full cure. The figure below shows an original and a surface created with textured polyester filler.

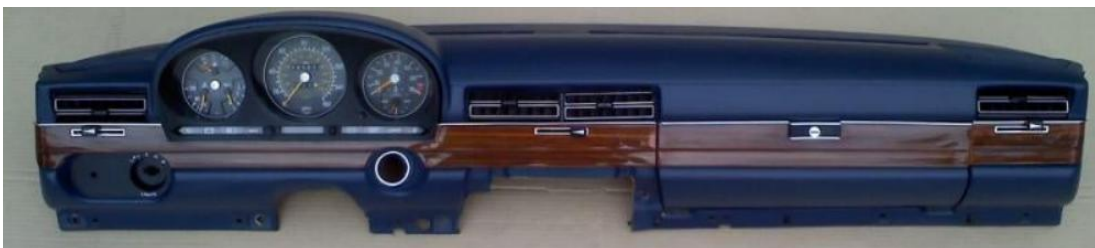
*Figure 8. Assembled complete restored and painted dashboard*

The curing time was 20 minutes to become dust-free, 6 hours for handling, and 48 hours to reach full chemical cure. Once the color coat has fully cured, a protective matte or semi-gloss topcoat may be applied. This provides additional UV resistance and helps replicate the original sheen of the dashboard material. The restored dashboard can then be reinstalled. All electrical connections, mounting points, and trim components must be reattached carefully to avoid stress on newly repaired areas. Proper alignment ensures that vents, gauges, and switches fit cleanly into the restored surface.
